OPERATING EXPERIENCE WEEKLY SUMMARY

Office of Nuclear and Facility Safety

February 27 through March 5, 1998

Summary 98-09

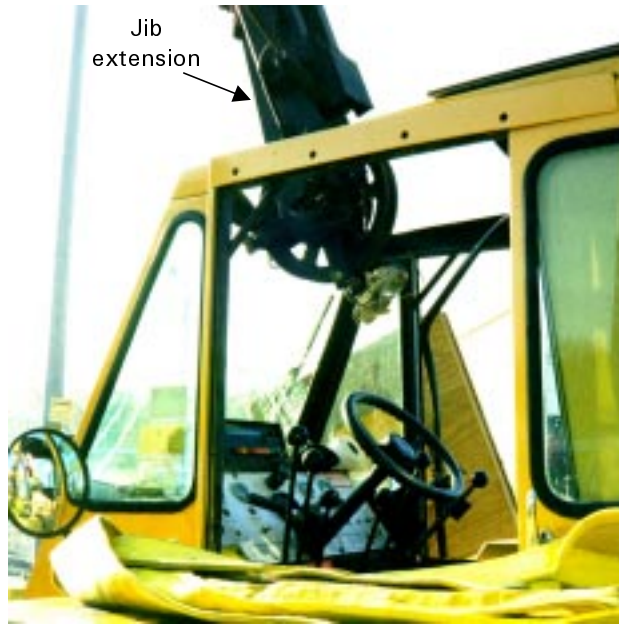
Figure 5-1. Jib Extension Entry Point

On February 24, 1998, at the Strategic Petroleum Reserves Weeks Island Site, a mobile crane operator was nearly hit by a crane jib extension when it swung free of the cradle and struck the crane cab. The jib broke the window and windshield, damaged the cab structure, and stopped approximately 6 inches from the operator's head. Investigators determined that the operator failed to release tension on a cable when he raised the crane boom, causing the jib extension to pull free from its cradle. The operator immediately shut down the crane, exited the cab, and notified the control room and site management. Personnel from the contracting organization returned the mobile crane to a safe configuration and removed it from the site for repairs. Failure to follow the equipment manufacturer's procedure resulted in crane damage and could have caused a severe personnel injury or a fatality. (ORPS Report HQ--SPR-WI-1998-0001)

Investigators determined that the contractor was preparing lift equipment to remove some small-diameter piping from a crude-oil metering skid for system decommissioning. Investigators reported that initially the jib extension was properly stowed on the underside of the boom in the cradle hooks. Investigators determined that the operator followed the procedure for preparing the jib for installation, properly set the outriggers, lowered and retracted the boom, and removed and secured the retaining pins. However, as the operator raised the boom, he forgot to slacken the hoist cable as indicated in an operating manual note. Investigators determined that when the operator raised the boom to a vertical position, the jib slipped off the retaining cradle and fell downward into the cab. Figure 5-1 shows the jib entry point into the crane cab. The crane boom and jib extension configuration are shown in figure 5-2.

The facility manager directed site and contractor personnel to investigate the accident. Accident investigators determined that the cause of this event was personnel error (inattention to detail). They continue to investigate to ascertain event details. The facility manager directed the crane operator to attend operator refresher training.
